**Region 9 Enforcement Division
75 Hawthorne Street
San Francisco, CA 94105**

Inspection Date(s):	9/30/15		
Time:	Entry: 1:00pm	Exit: 2:15pm	
Media:	Water		
Regulatory Program(s)	Clean Water Act NPDES /CAFO Dairy		
Company Name:	TIVA Dairy		
Facility or Site Name:			
Facility/Site Physical Location:	Ex. 6 Personal Privacy (PP)		
Geographic Coordinates:			
Mailing address:			
Facility/Site Contact:	Dickie Vander Meulen	Title: Owner/Operator	
	Phone: Ex. 6 Personal Privacy (PP)	Email:	
Facility/Site Identifier:	NPDES CAG018001 / Order R8-2013-0001, General waste discharge requirements for CAFOs (dairies and related facilities)		
NAICS:	112120 Dairy Cattle and Milk Production		
SIC:	0241 Dairy Farms		
Facility/Site Personnel Participating in Inspection:			
Name	Affiliation	Title	Email
Dickie Vander Meulen	TIVA Dairy	Operator	
EPA Inspector(s):			
John Tinger	EPA	Engineer	Tinger.John@EPA.gov
Federal/State/Tribal/Local Representatives:			
Edward Kashak	WRCB-R8	Engineering Geologist	ekashak@waterboards.ca.gov

The purpose of the inspection was to ensure compliance with the NPDES permit and applicable Federal regulations covering the discharge of wastewaters into waters of the United Sta

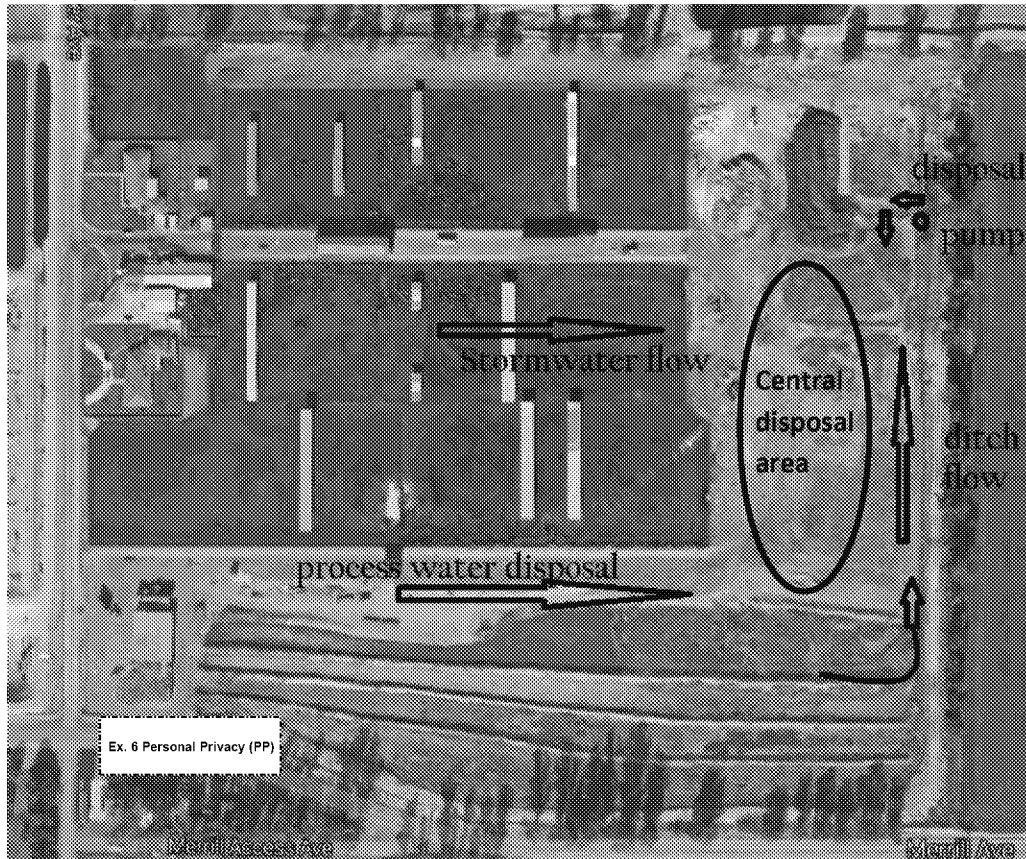
1 – Facility overview.

Washwater from the milking barn area gravity drains through underground pipes to the southern portion of the dairy where it is directed to one of 4 standpipes for discharge to the disposal area. The disposal area consists of 4 bermed areas which drain towards the eastern end of the facility. (see photo 1). The operator manually directs the wastewater to one of the 4 standpipes. At the time of the inspection, wastewater was actively flowing into the 2nd northernmost bermed area (photo 3). The operator stated wastewater has been directed to this bermed area for approximately 2 weeks. Previously, the northernmost bermed area had received wastewater (photo 4). At the time of the inspection, the solids in the northernmost area had been drying for approximately 2 weeks, and the operator stated he anticipates removing the solids within the month when the solids are sufficiently dry to accommodate equipment.

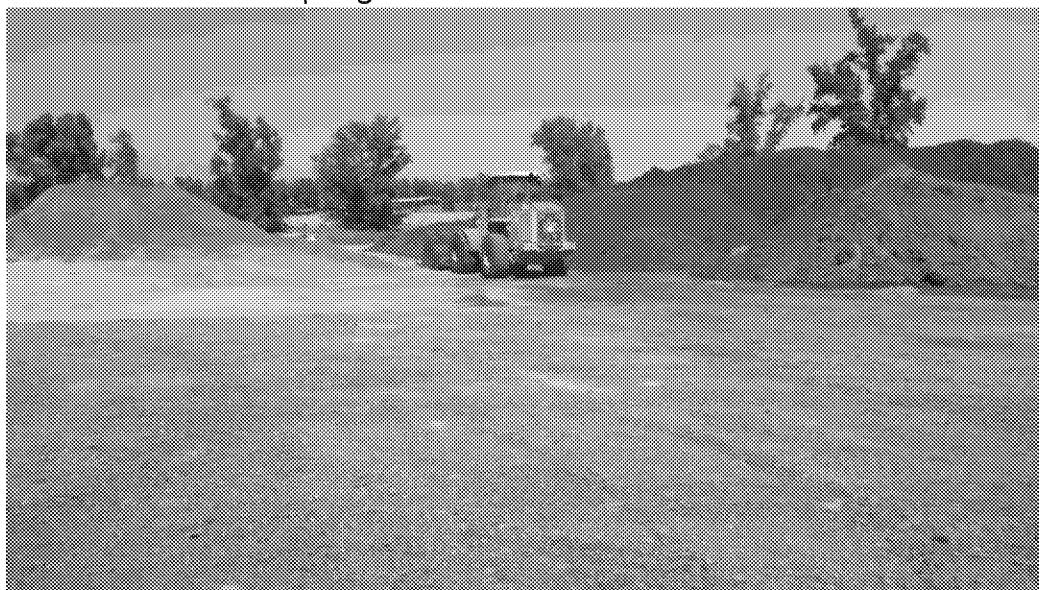
Photo 2: Manure stockpiling

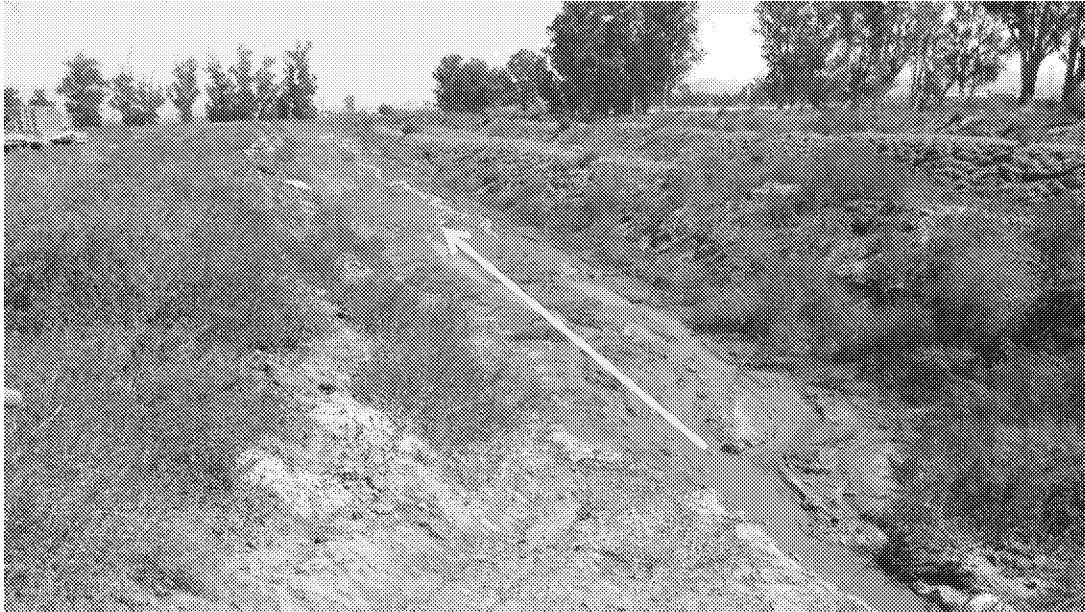
Photo 3: 2nd (from north) bermed area actively receiving washwater from standpipe and flowing east. View looking east.

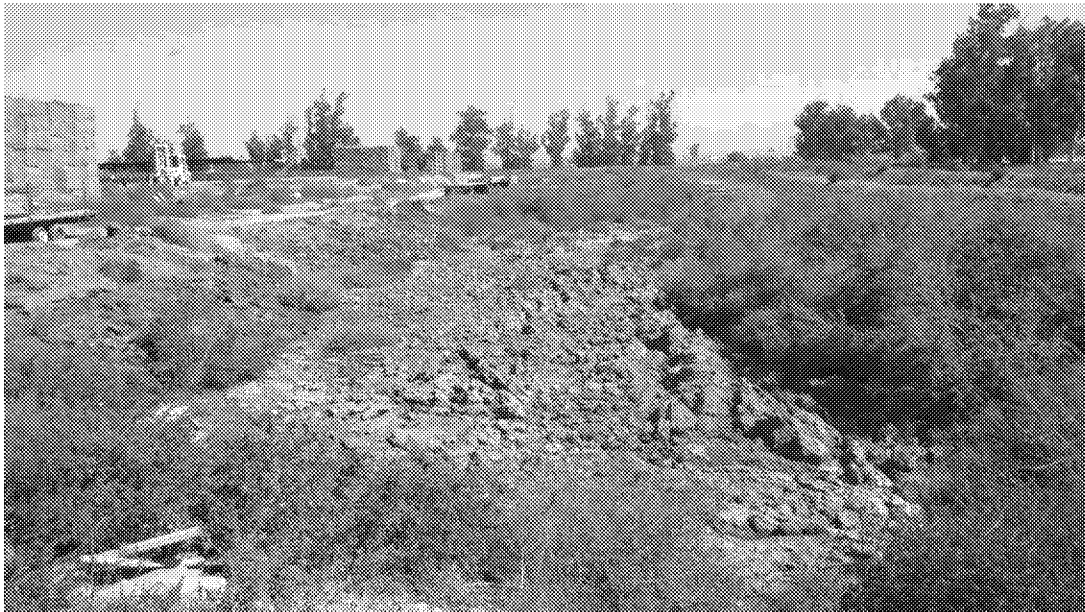
Photo 4: 1st (northernmost) bermed area with solids. View looking east.

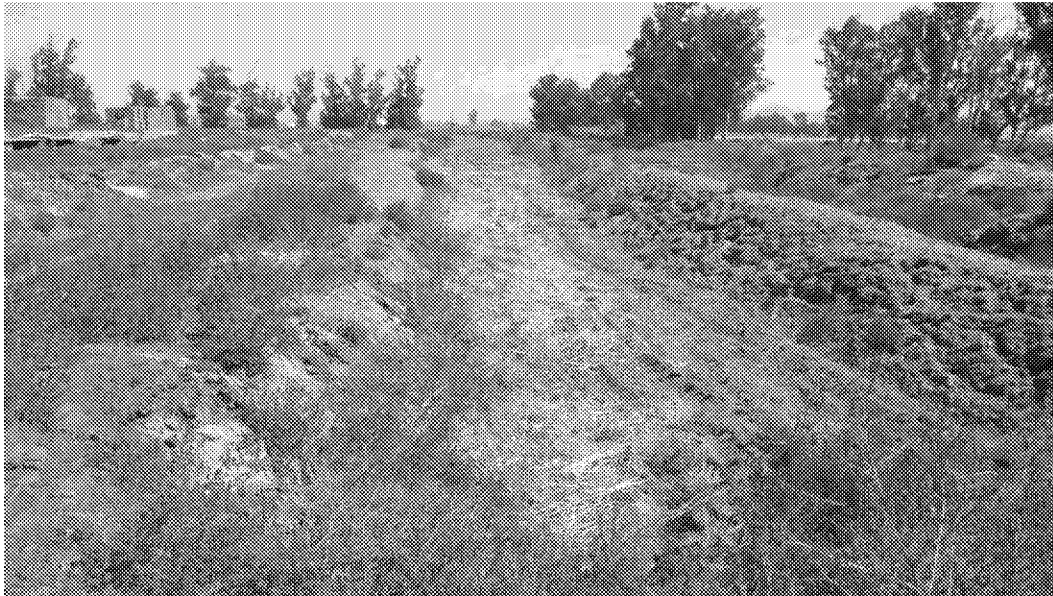
Photo 5: 3rd (from north) bermed area inactive after solids have been removed. View looking east.

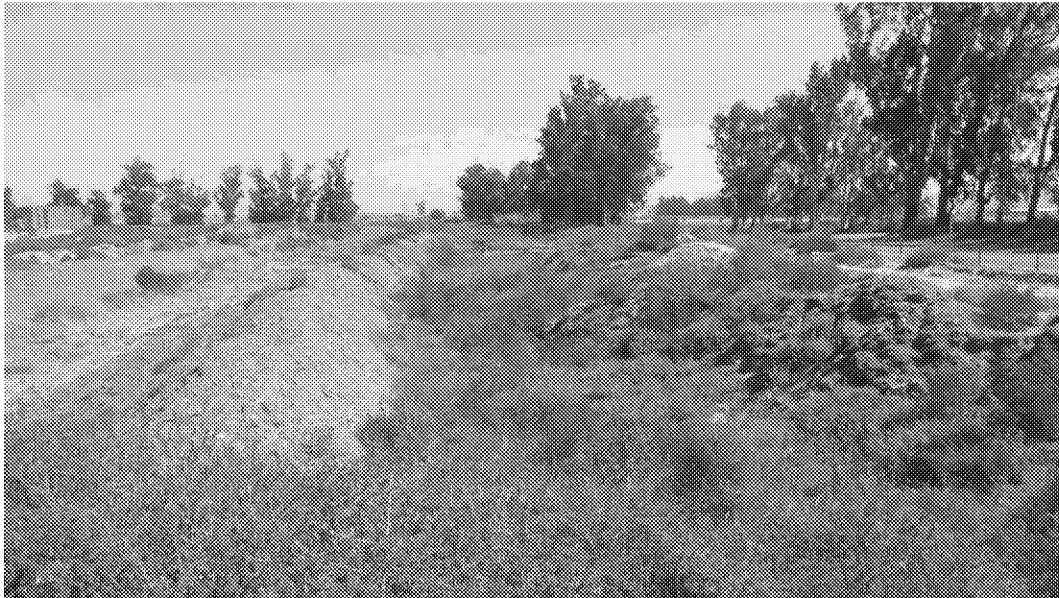
Photo 6: 4th (from north) bermed area inactive. View looking east.

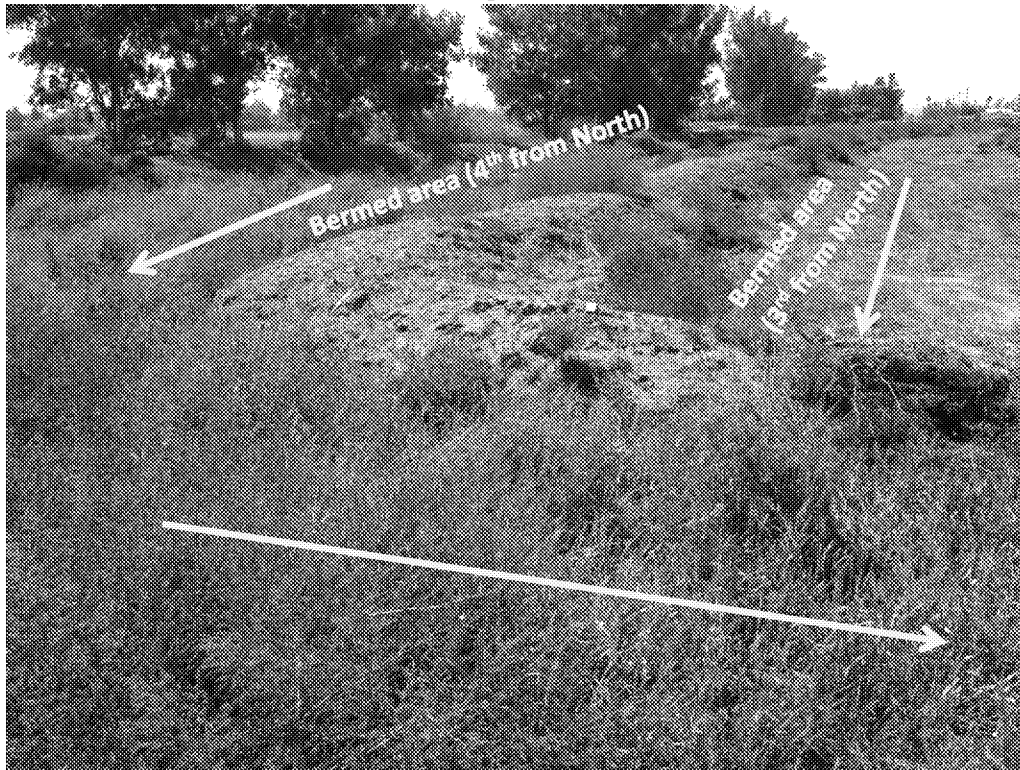
Photo 7: Southeastern edge of facility. Bermed areas turn corner and flow is directed northerward into ditch. View looking west.

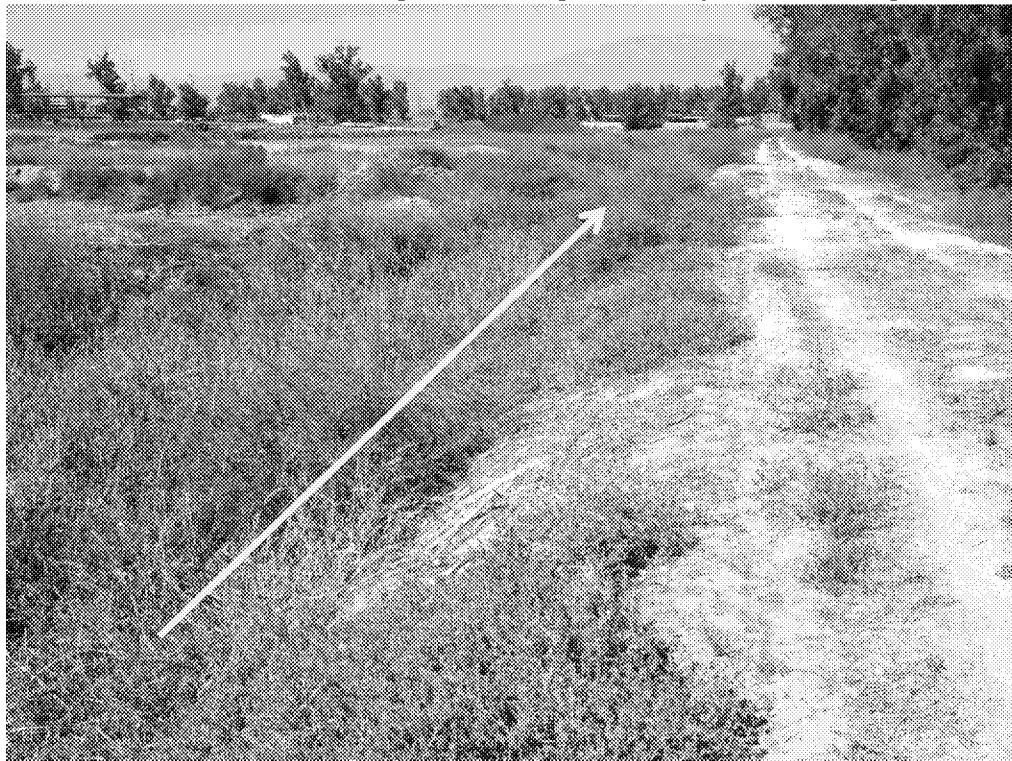
At the eastern end of the bermed areas, the berms are several feet lower to create a spillway into a ditch running alongside the eastern boundary (photo 8). The ditch was observed to contain heavy vegetation cover, especially in the southeast corner. The ditch directs wastewater northward back towards the center of the facility. At the end of the ditch, the operator has installed a pump (photo 10). When the ditch is full, the operator pumps wastewater to the northernmost disposal area where it infiltrates (photo 11). Excess wastewater from this pasture area may overflow to the center disposal area (photo 12).

Exterior berms appeared to be properly constructed. No rodent holes observed, minimal vegetation along tops of berms. Excess vegetation observed in ditches alongside berm.

Photo 8 : Ditch and berm along eastern edge of facility. View looking North.

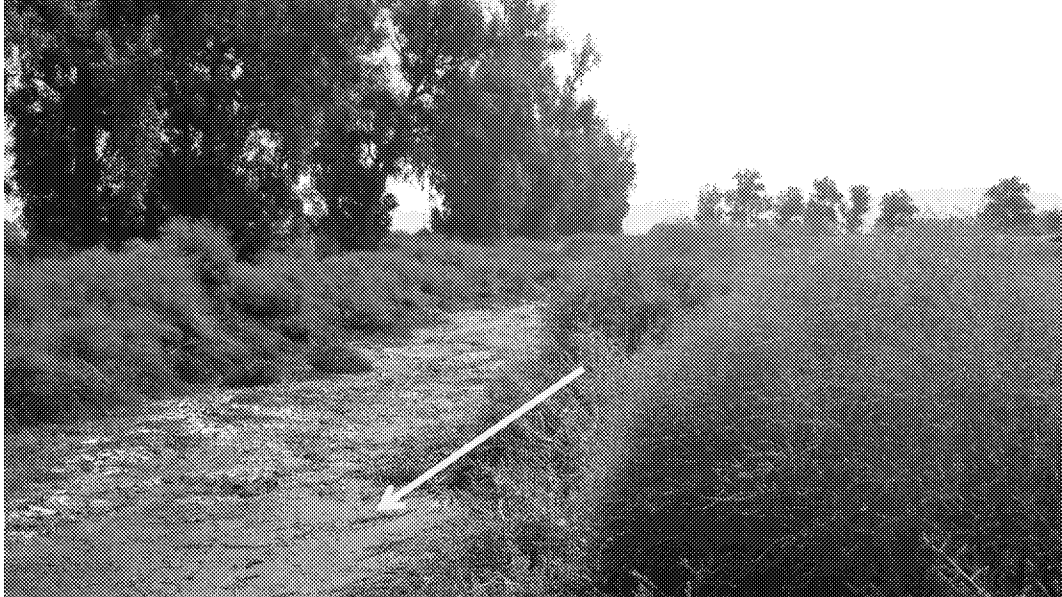
Photo 9: Ditch and berm along eastern edge of facility. View looking south.

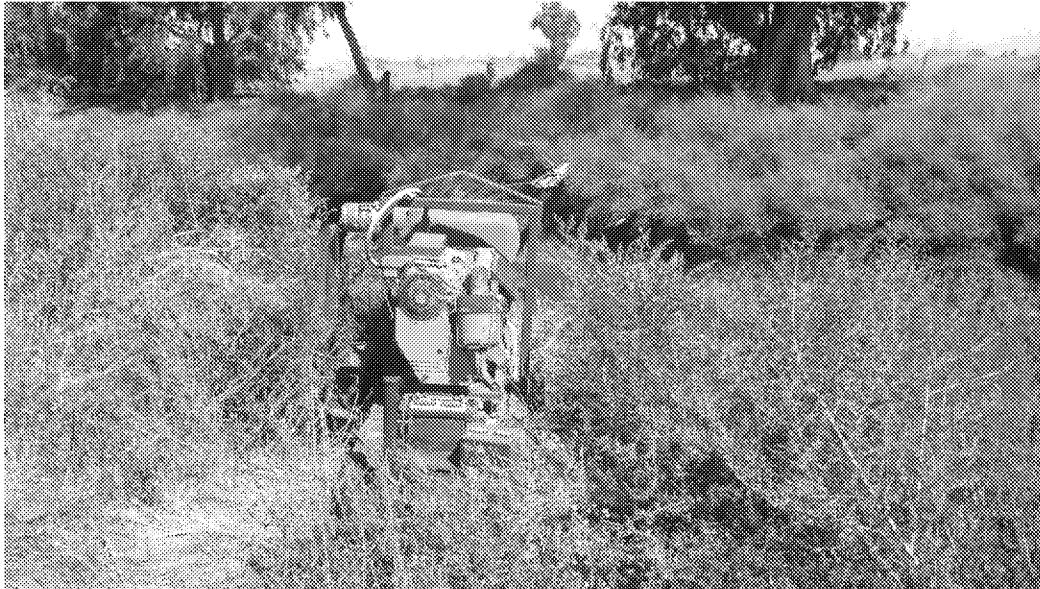
Photo 10: Pump in ditch

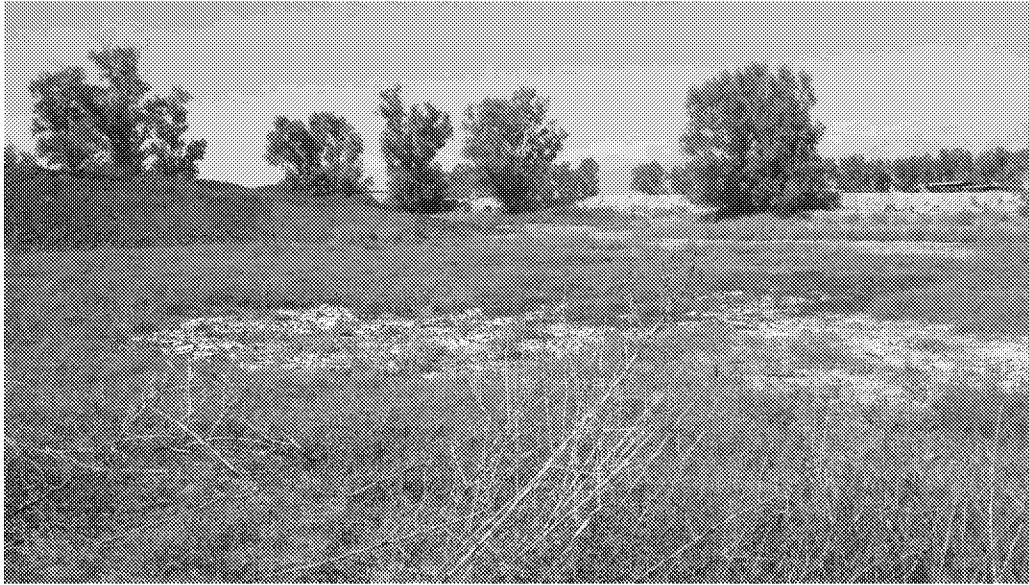
Photo 11: Disposal area adjacent to ditch for water pumped from ditch.

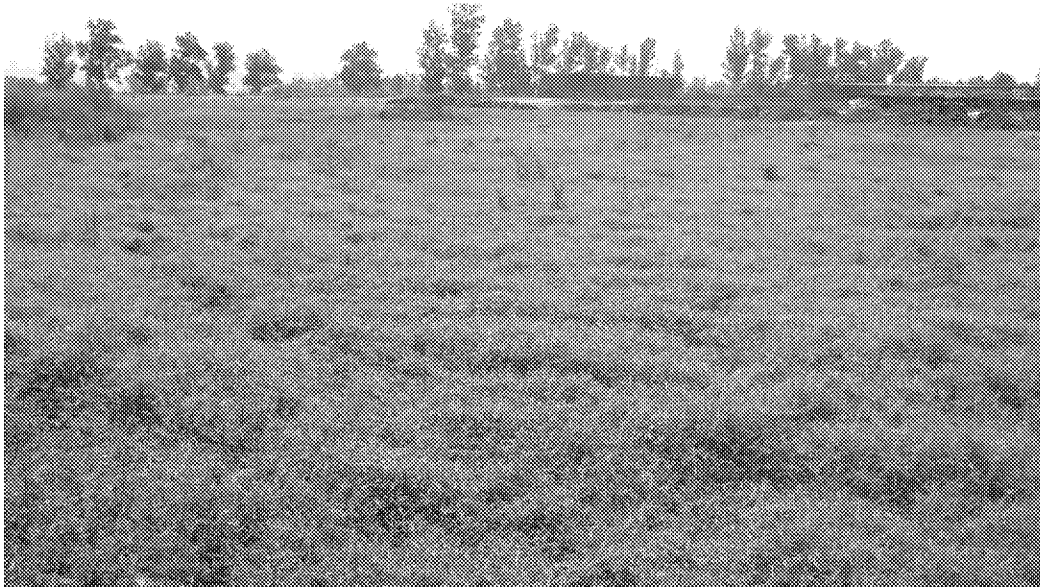
Stormwater generally flows from the corrals towards the center and easterly direction to the disposal areas (photo 12). The soils in the disposal area were observed to be sandy and very porous. The operator noted the high percolation rates in this area, and stating that 2' of water will drain overnight. The operator rips the disposal area as needed to encourage infiltration in this area. The operator recently bought a new disc ripper to facilitate ripping the area.

Photo 12: disposal area in center of eastern section of facility. This area receives stormwater flow from corrals, and receives any overflow from the disposal area in photo 11. The area is disked to promote infiltration. View looking northwest.
